**TRINIDAD AND TOBAGO CIVIL AVIATION AUTHORITY**

**FINAL INVESTIGATION REPORT  
OF ACCIDENT INVOLVING 9Y-TJU  
NEAR PIARCO INTERNATIONAL AIRPORT  
ON OCTOBER 19, 2021**

### 9Y-TJU Crash Landing during Student Pilot Training

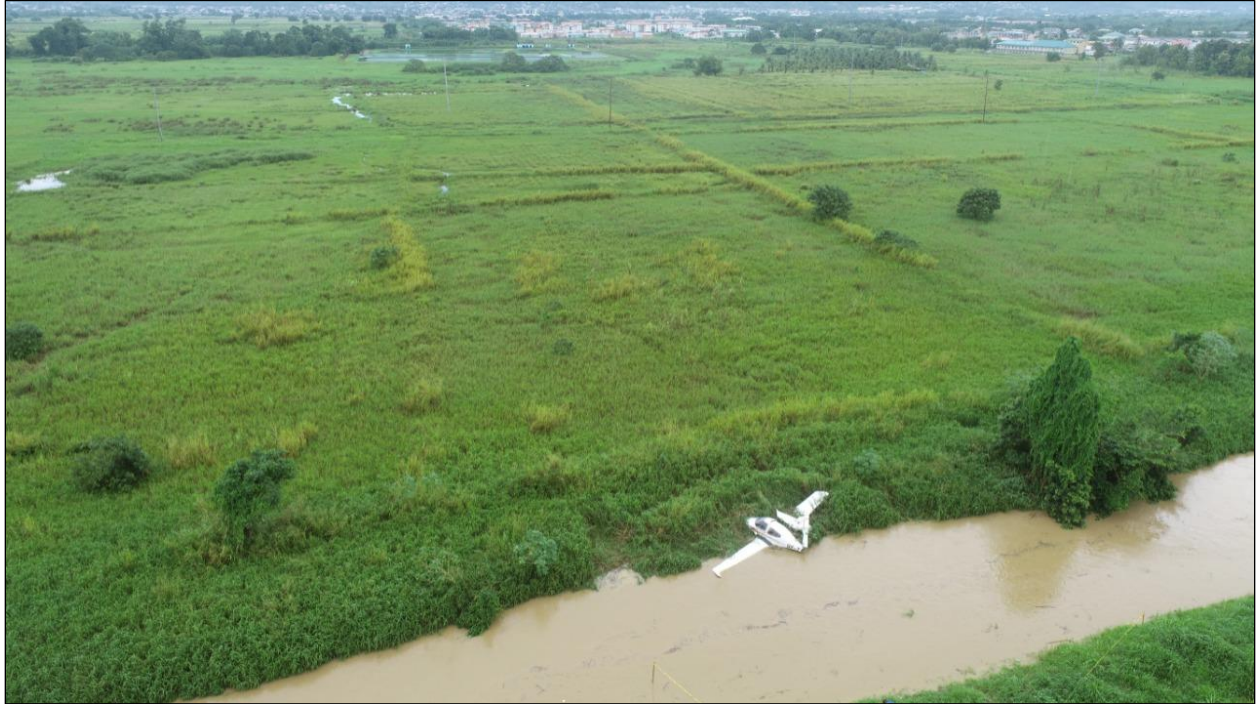
**Figure 1: Crashed aircraft on the bank of the Oropune River.**

On October 19, 2021 at approximately 9:47 local time, 9Y-TJU, a Diamond Aircraft (DA-40, light single engine aircraft) operated by Aerial World Services Limited (AWSL) landed short of the airfield approximately one (1) mile north-west of the threshold to Piarco International Airport, Runway 10. The result was a hull loss and minor injuries to the two souls on board. **(See Figure 1.)**

- The choice of field for the emergency landing was appropriate and landing in the direction of the ploughed furrows was correct.
- The presence of the river was not observed and consequentially, the riverbank was not catered for. Striking the riverbank was the major factor causing the damage to the aircraft and the minor injuries.

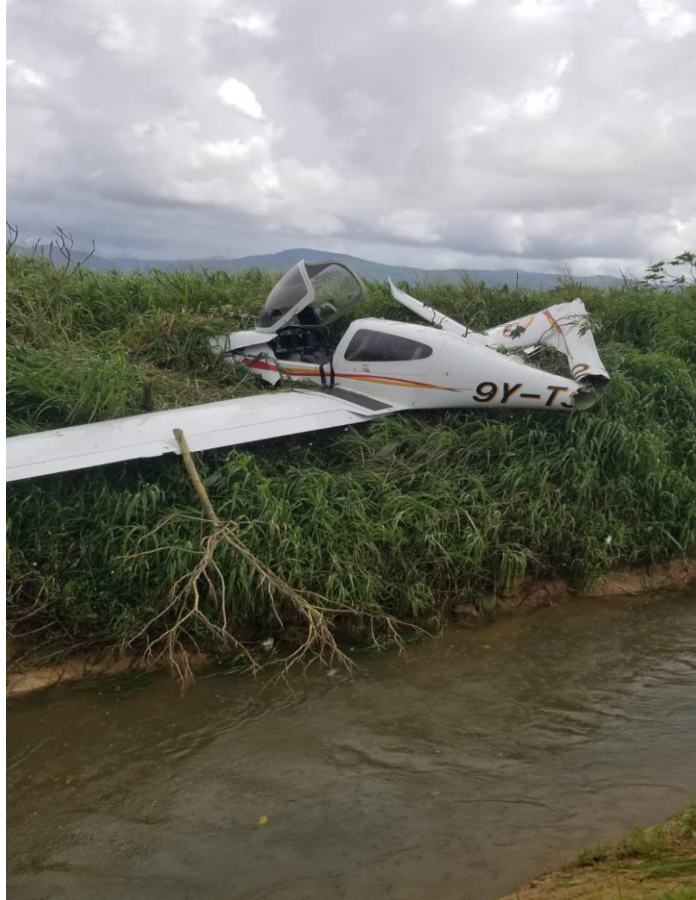
- The hull of the aircraft sustained significant damage including but not limited to main undercarriage dislocation, nose gear broken off at attachment points and almost complete separation of the tail from the aircraft. (See Figure3.)

**Figure 3: An image of the crashed aircraft, 9Y-TJU.**  
Source: TTCAA Safety Regulation Division, 2021
