**TRINIDAD AND TOBAGO CIVIL AVIATION AUTHORITY**

**FINAL INVESTIGATION REPORT  
OF ACCIDENT INVOLVING 9Y-TJU  
NEAR PIARCO INTERNATIONAL AIRPORT  
ON OCTOBER 19, 2021**

### 9Y-TJU Crash Landing during Student Pilot Training

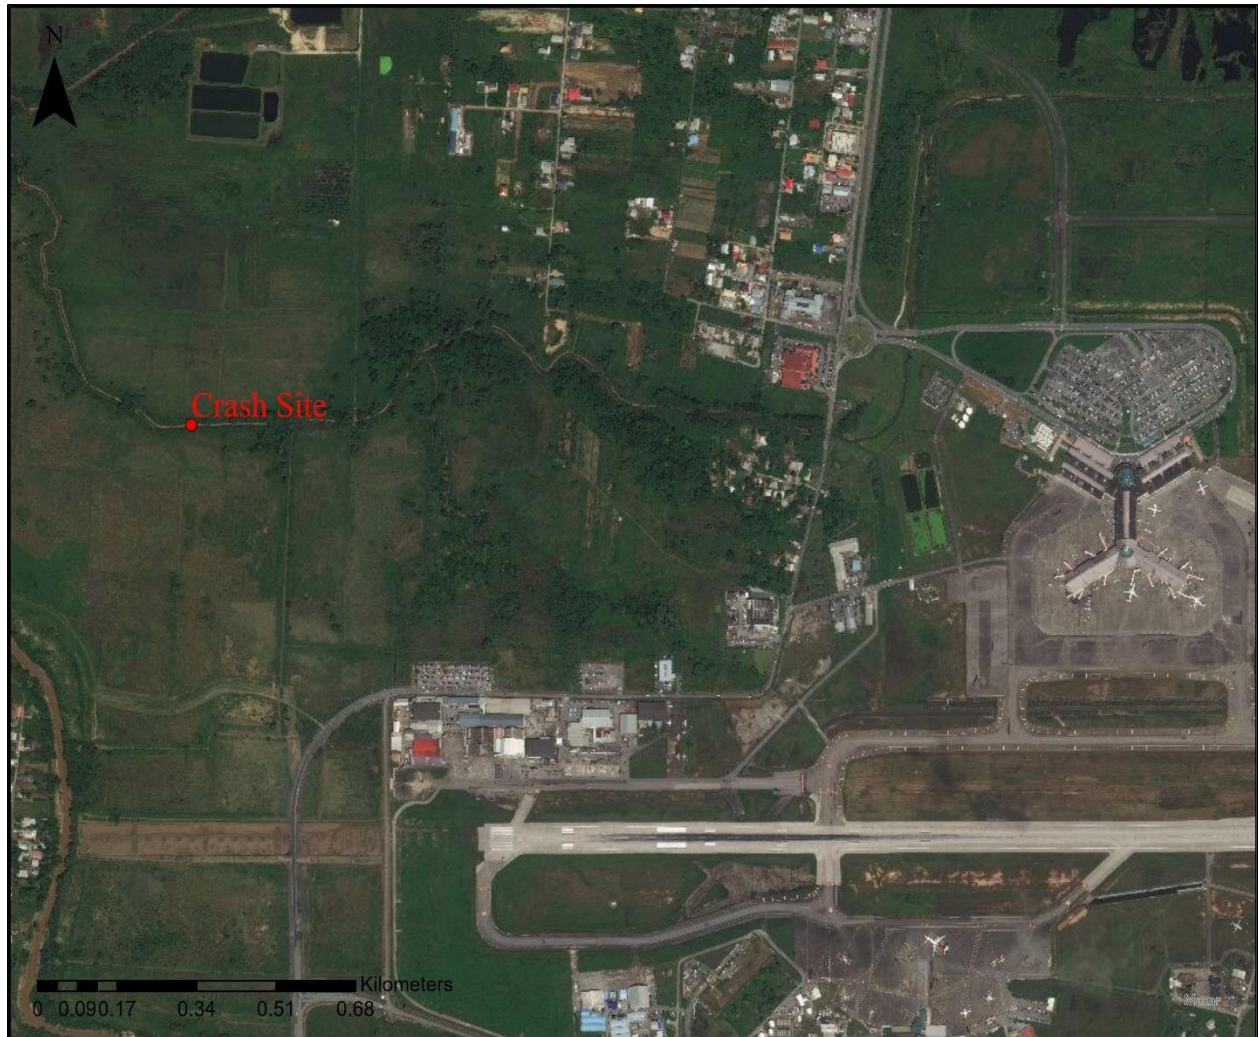
**Figure 2: Map showing the Crash Site.**

- The aircraft landed short of the airfield approximately one mile north-west of the threshold to runway 10 at Piarco International Airport. **(See Figure 2.)**
- The aircraft, operated by the Instructor, completed one (1) flight previous to the accident. There was no indication of engine trouble during that previous flight and up to the time of the accident.

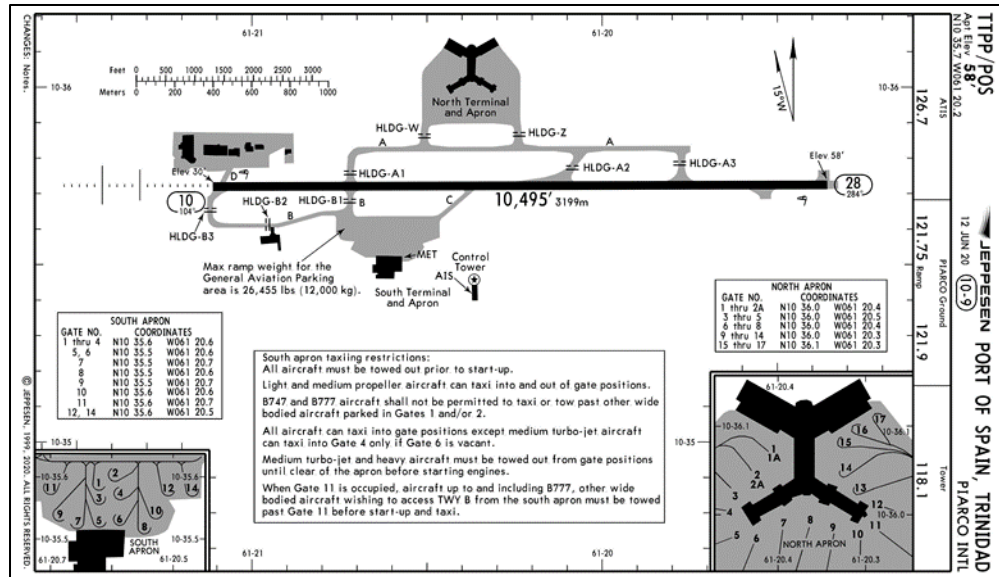
Figure 4: Jeppesen Chart of the Piarco Aerodrome.

- Piarco International Airport is an international airport serving the island of Trinidad.
- The airport has two runways (010 and 028) which are ten thousand five hundred feet (10,500 ft) long and sit at fifty-eight (58) feet above sea level. **(See Figure4.)**
